MECA & FLUID

Technical Services and Solutions

- Building of pneumatic cabinets and plates
- Sizing, installation and after-sales service of compressors and dryers
- Maintenance of valves and cylinders
- Assembly of motorized valves
- Qualified technical team

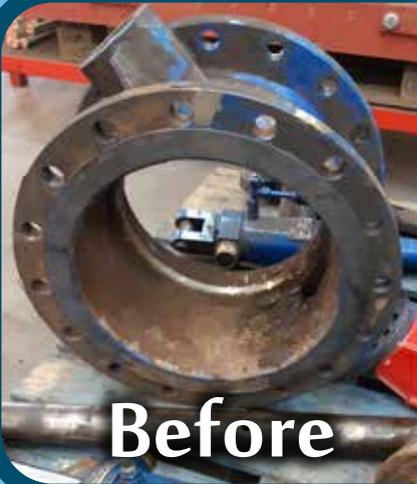
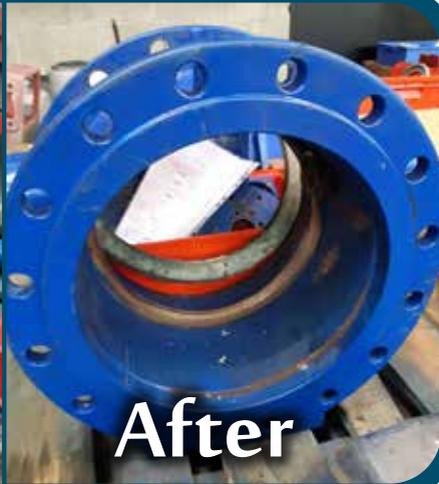
Maintenance of valves and cylinders

- Seat lapping
- Axis machining
- Paint job
- Gasket replacement

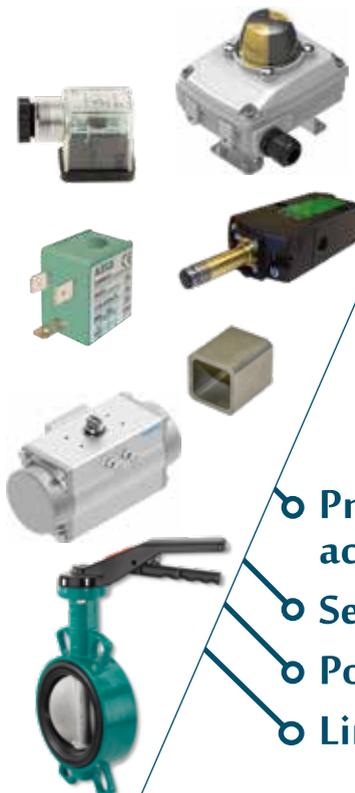
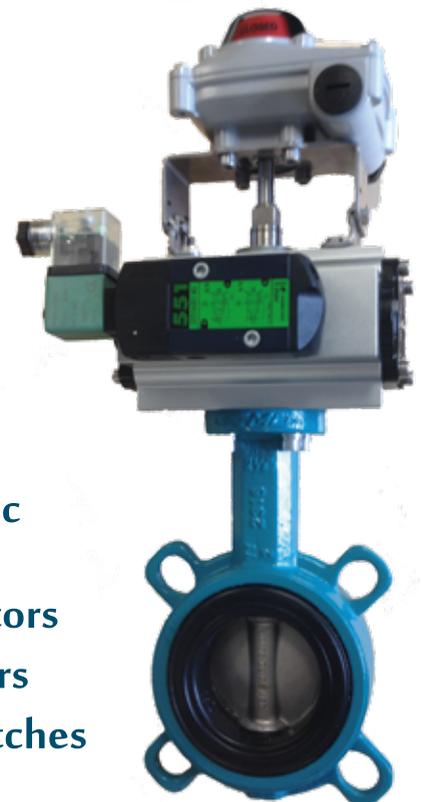
Assembly of motorized valves

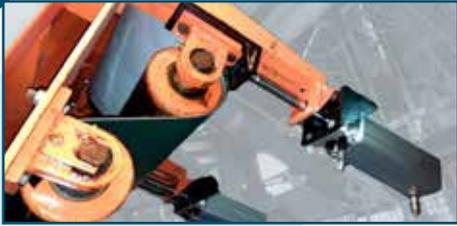
1. Band tensioner for steel coils

In order to unwind its steel coils, a major company in the Liège metallurgy industry used a mechanical system for tensioning the unwinding bands. By tightening or loosening a nut on a threaded rod, the maintenance technician applies a certain tension to the system. The customer has two such systems.

Our client first asked us to study the replacement of the threaded rod with pneumatic cylinders. After the study carried out by our Technical Services and Solutions Department, we installed pneumatic cylinders on the first system, continuously adjusting the tension of the belts.

- **Sizing the Aventics cylinders** so that they apply the necessary tension (neither too high nor too low).
- The **space** available for installing the cylinders being quite **small**, we had to minimize their sizes while maximizing their efforts so that they could exert sufficient tension.
- From a safety point of view, we recommended the customer to **use a rod lock** because, in the event of a possible loss of pressure in the customer's compressed air system, the cylinders must remain in place and continue to hold the tape.

- Compulsory stoppage of the production line to adjust the tension (**loss of time**).
- Belt wear is not controlled because the **manual intervention performed is less precise**.
- The presence of technicians so close to the line increases the **risk of accidents**.

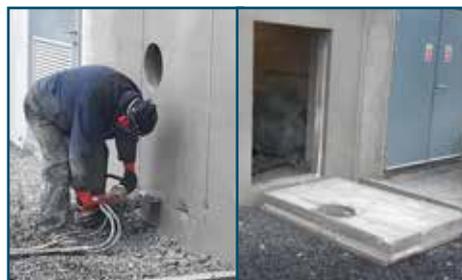
1. replace the existing compressor with a **new one**, much more suited to its current production ;

3. **improve the quality of its air** by installing an air dryer and a water separator ;

4. install a buffer tank allowing **better management of the working hours of the compressor** ;

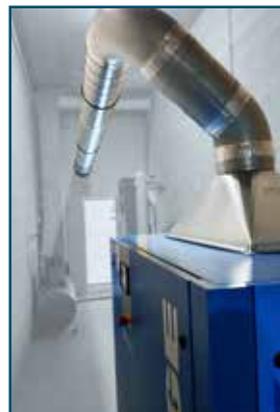
- **Avoid overheating of the room** by installing (1) a duct on the discharge part of the compressor as well as (2) the installation of a ventilation grille to bring cold air into the room and allow the correct suction flow rate of the compressor.

Thanks to these adaptations, the new compressor no longer overheats and is now adapted to the customer's compressed air consumption. This therefore results in a
